Manhole Inspection Summary

Manhole # S25QQ1008MH

Location Address: **4708 ROLAND AVE**

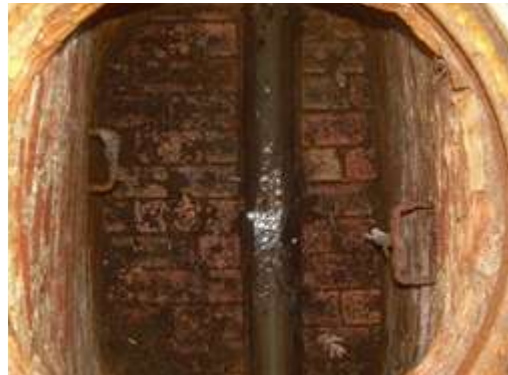
Top View

Evidence of surcharge - Bench debris.
Corroded steps.

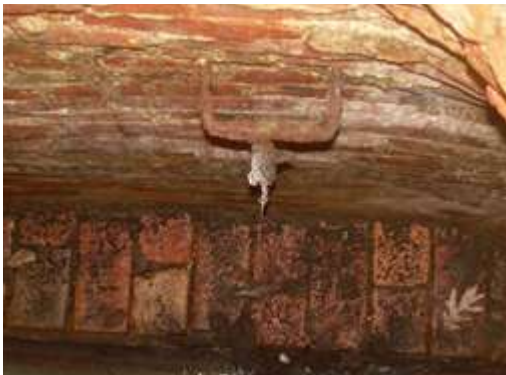
Evidence of surcharge

Surcharge ☒ **Evidence Of Surcharge** Depth: **4** (ft.) ☐ Active Surcharge Present

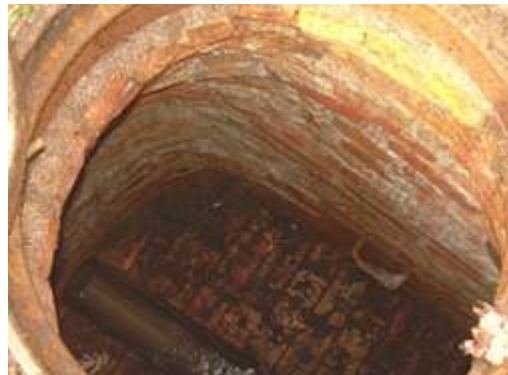
Defect

Adjustment and Corbel deterioration and
infiltration. Barrel infiltration - other
side.

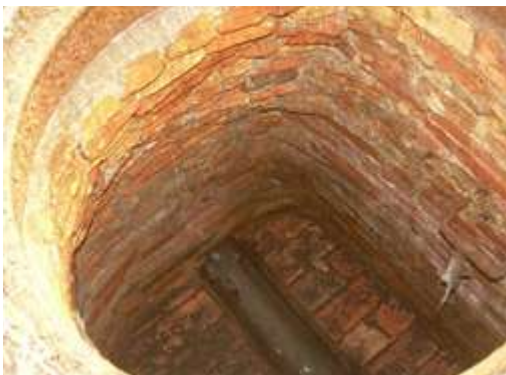
Defect

Adjustment and Corbel deterioration and
infiltration. Barrel infiltration.

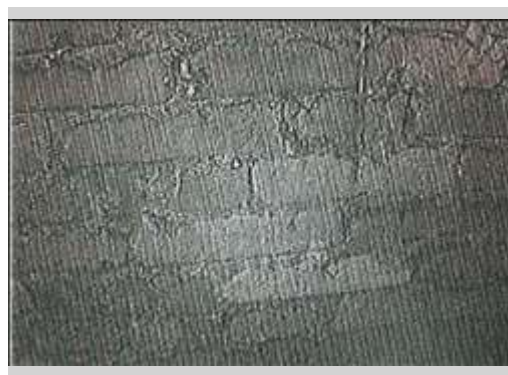
Defect

Barrel deterioration and infiltration.

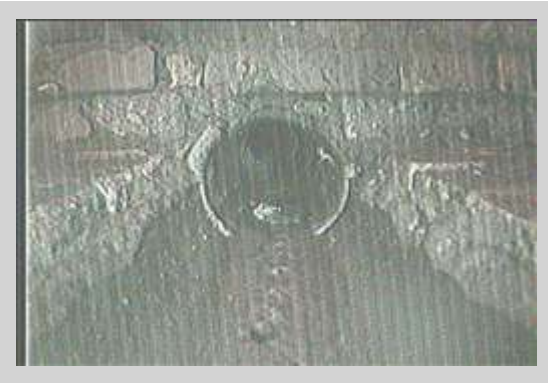
8 in. Circular Gravity Sewer Pipe Out @ 12 O'Clock

Barrel deterioration and infiltration.

Infiltration: **Evidence** Pipe Seal Cond: **Broken**

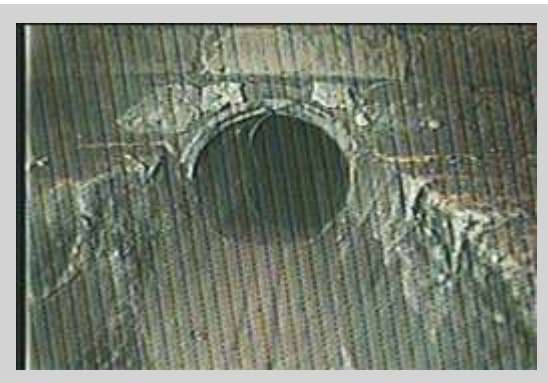
8 in. Circular Gravity Sewer Pipe In @ 6 O'Clock

Barrel deterioration and infiltration.

Infiltration: **Evidence** Pipe Seal Cond: **Cracked**
